A Water Quality Report-An Examination of Illegally
Connected Sanitary Sewers That Empty into Doan Brook

Charles R. Steffel
June, 1970

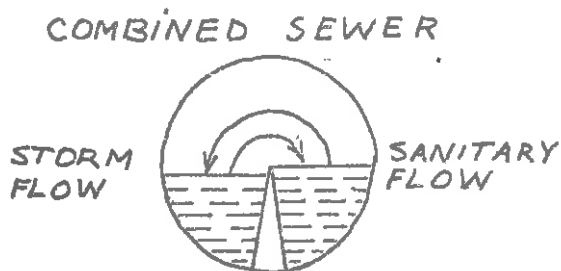
SEPERATE SEWERS AT AN OVERFLOW

WHEN EITHER FLOW EXCEEDS
THE DESIGN, THE TWO MIX

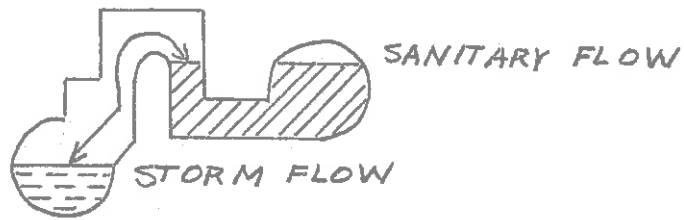
HIGH PRESSURE DUE TO A LARGE FLOW OF EITHER SANITARY OR STORM WILL CAUSE MIXING.

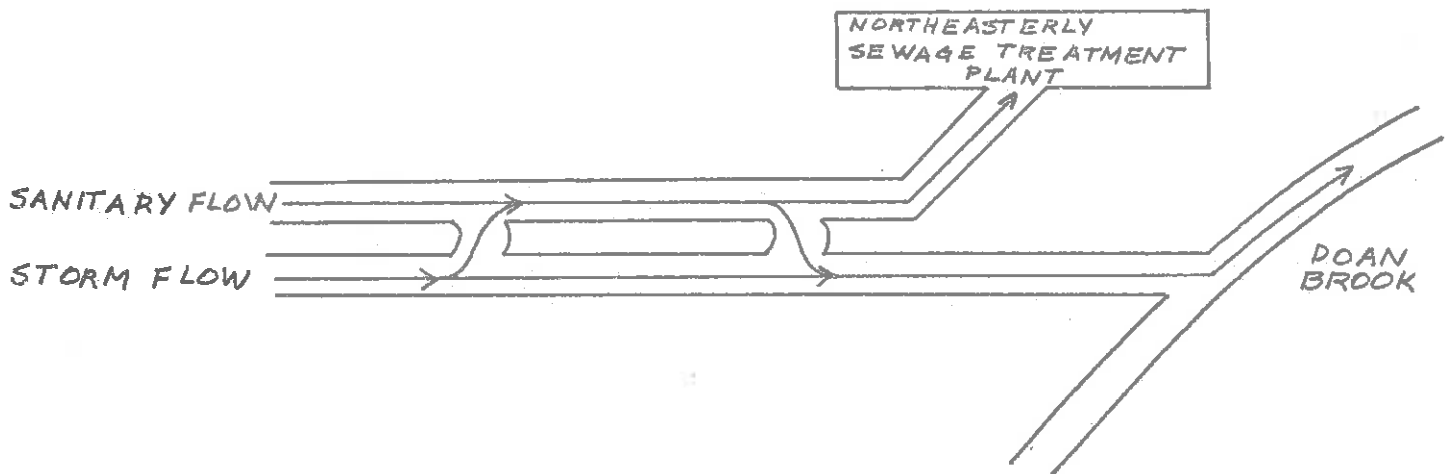
In spite of this relief of pressure within the sanitary sewer pipes, some sewage continues to overflow into Doan Brook.

This situation is not ideal, but, sanitary sewage is diluted and it cannot approach the damage done by concentrated sanitary sewage. These effects are recorded in the Log of April 12, 1970, at Fairhill and Coventry and in photos of June 2, at Torrington South Branch.
