A Water Quality Report-An Examination of Illegally
Connected Sanitary Sewers That Empty into Doan Brook

Charles R. Steffel
June, 1970

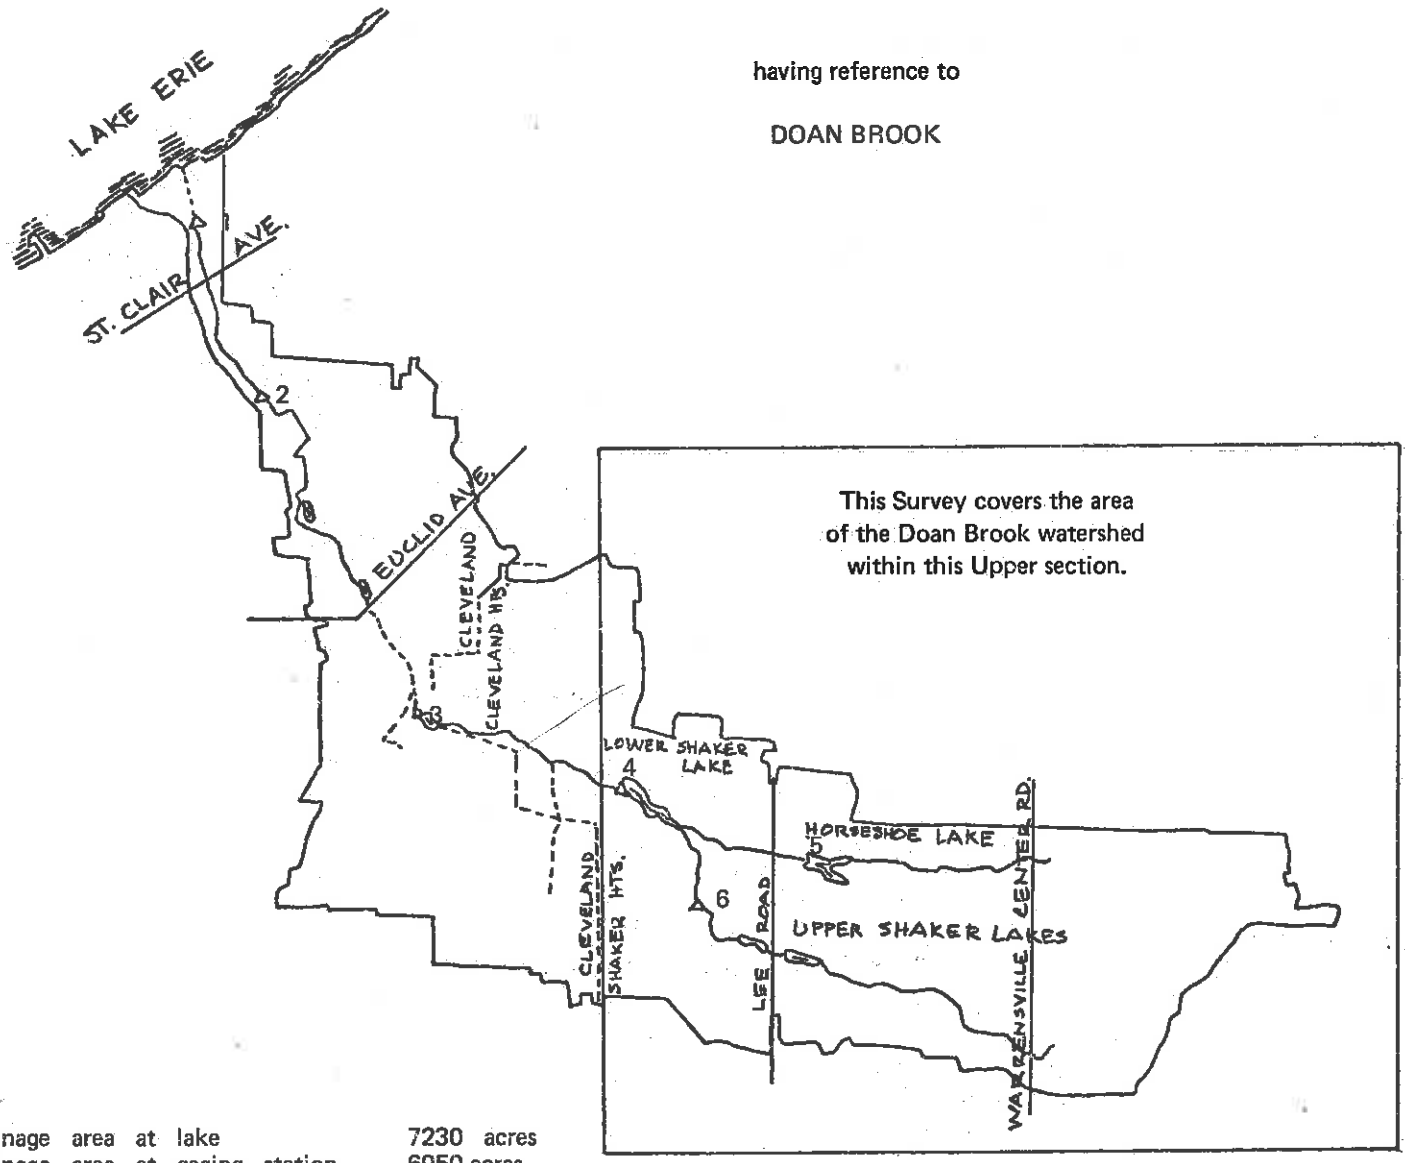
MAP NO. 1
 Excerpts from the HAVENS AND EMERSON REPORT
 (also called The Cleveland Report)

Drainage area at lake	7230 acres
Drainage area at gaging station	6950 acres
Length of open channel	8.1 miles
Length of enclosed channel	1.3 miles
Average slope	60 ft./mile
Open space	1820 acres
